Breaking Secure Bootloaders

Project One – The SDM660 Android Bootloader

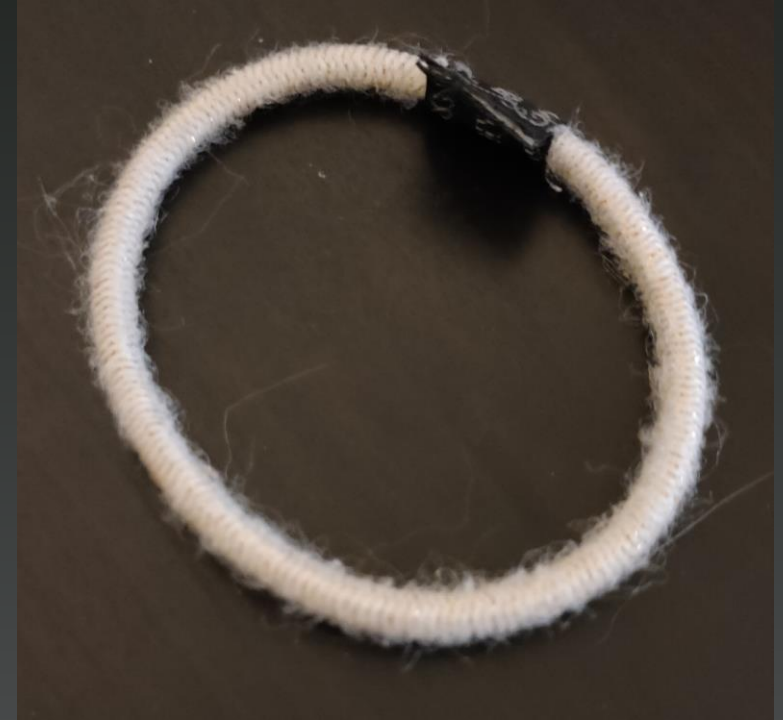
Instead, a hair tie was wrapped around the power and volume down buttons

This caused a boot loop which allowed USB access for sufficient time to test the overflow

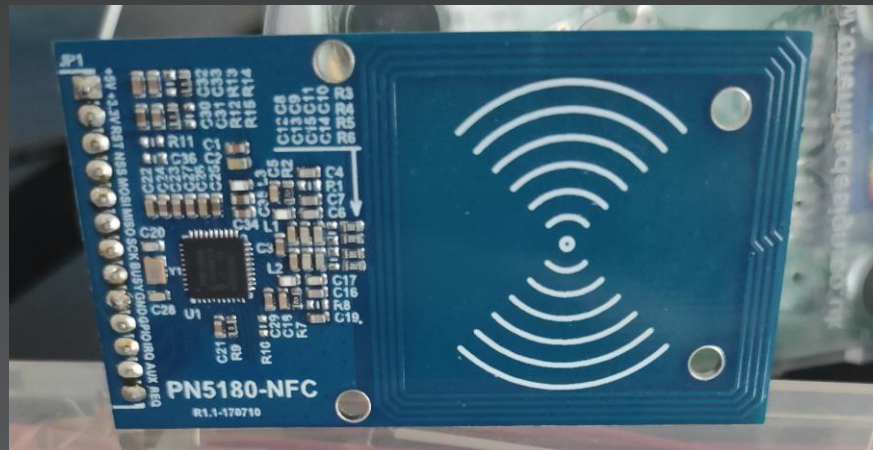
Replicating The Vulnerability – PN5180

Can be communicated with via an SPI interface and GPIO pins

The firmware update process was the same, allowing the signature bypass to be replicated
